Shake table testing of a half-scale stone masonry building aggregate

I. Tomić¹ · A. Penna² · M. DeJong³ · C. Butenweg⁴ · A. A. Correia⁵ · P. X. Candeias⁵ · I. Senaldi⁶ · G. Guerrini² · D. Malomo⁷ · K. Beyer¹

Abstract

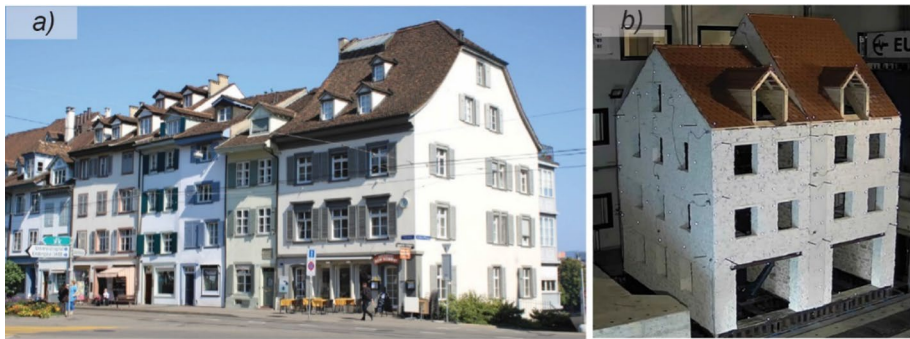
Fig. 1 **a** Example aggregate in Basel, Switzerland; **b** Half-scale masonry aggregate tested at the EUCENTRE

Although multiple experimental campaigns were performed on stone masonry buildings (Tomažević et al. 1991; Magenes et al. 1995, 2014; Benedetti et al. 1998; Mazzon et al. 2010; Senaldi et al. 2014; Vintzileou et al. 2015), only a single experimental campaign (Senaldi et al. 2019a; Guerrini et al. 2019) investigated the interaction between the adjacent buildings in an aggregate. A stone masonry aggregate was designed at the University of Pavia, Italy, to reproduce the features typical for the historical centre of Basel, Switzerland, and was tested on the EUCENTRE shake table in Pavia, Italy both in original and strengthened configurations. The aggregate was composed of two adjacent three-storey units that were weakly connected by interlocking stones. The walls were constructed from double-leaf undressed stone masonry. The floors were composed of timber beams and one layer of planks and were therefore assumed to act as flexible diaphragms in their plane. The floor beams of the adjacent units were at the same level; they were connected to each other by steel elements as part of a possible strengthening solution. The specimen was built to half-scale, and the material properties were scaled accordingly to respect the similitude laws, with detailed material characterizations performed before the test (Guerrini et al. 2017; Senaldi et al. 2018). The specimen is shown in Fig. 1.

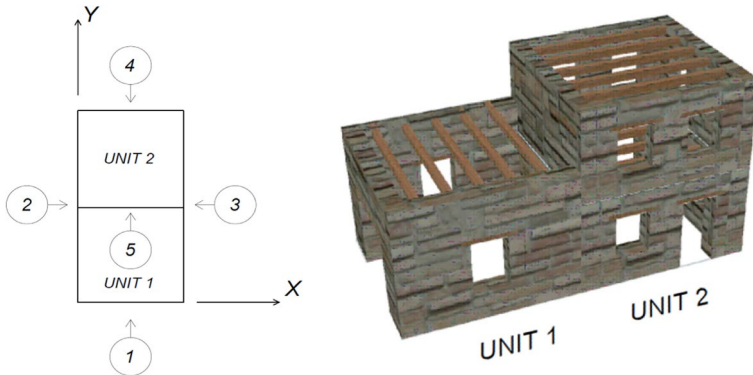
Fig. 2 Unit orientation and facade numbering of the half-scale stone masonry aggregate tested in this study

The specimen was constructed as a half-scale stone masonry aggregate consisting of two units. The orientation of the units with respect to the x – y reference system and the labels of the walls are shown in Fig. 2. Masonry typology and material properties reproduced, as much as possible, those of the aggregate tested by the University of Pavia (Senaldi et al. 2019a; Guerrini et al. 2019). The construction sequence replicated that of historical city centres such that Unit 2 was constructed before Unit 1 to ensure no interlocking between the units at any given height.

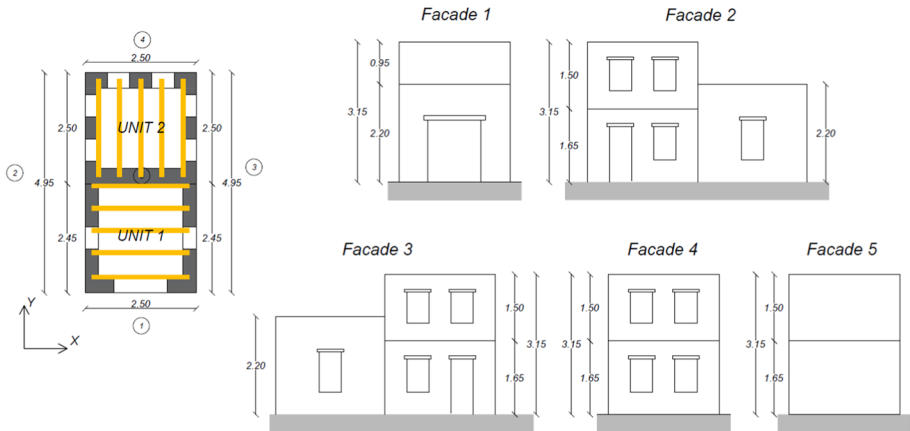
Fig. 3 Plan view and elevations with dimensions of the half-scale stone masonry aggregate tested in this study. Units of m

The main dimensions are shown in Fig. 3. Unit 1 had a single storey with a height of 2.2 m, while Unit 2 had two storeys with heights of 1.65 m and 1.5 m, respectively, for a total height of 3.15 m. Unit 1 had a U-shaped three-wall layout with plan dimensions of

$2.5 \times 2.45 \text{ m}^2$. Unit 2 was rectangular with four walls and plan dimensions of $2.5 \times 2.5 \text{ m}^2$. Unit 1 had a wall thickness of 30 cm, while Unit 2 had wall thicknesses of 35 cm and 25 cm for the first and second storeys, respectively. The thickness of the spandrels was decreased to 15 cm underneath the openings.

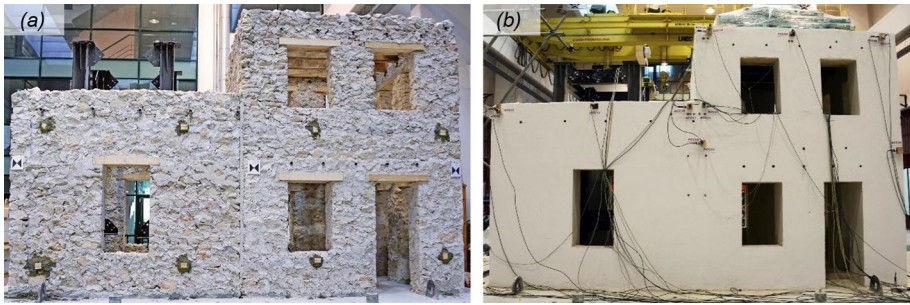
Fig. 4 Facade 3 of the half-scale stone masonry aggregate specimen: **a** Without plaster, paint, and additional masses; **b** Completed test specimen

To finish the building, a layer of plaster was applied using mortar of class NHL 2.0, without fibres. The plaster thickness depended on the surface roughness and was approximately 15 mm on average. A layer of paint was applied afterwards to make cracks more visible. The specimen is shown in Fig. 4 before and after application of plaster, paint, and additional masses of Unit 2.

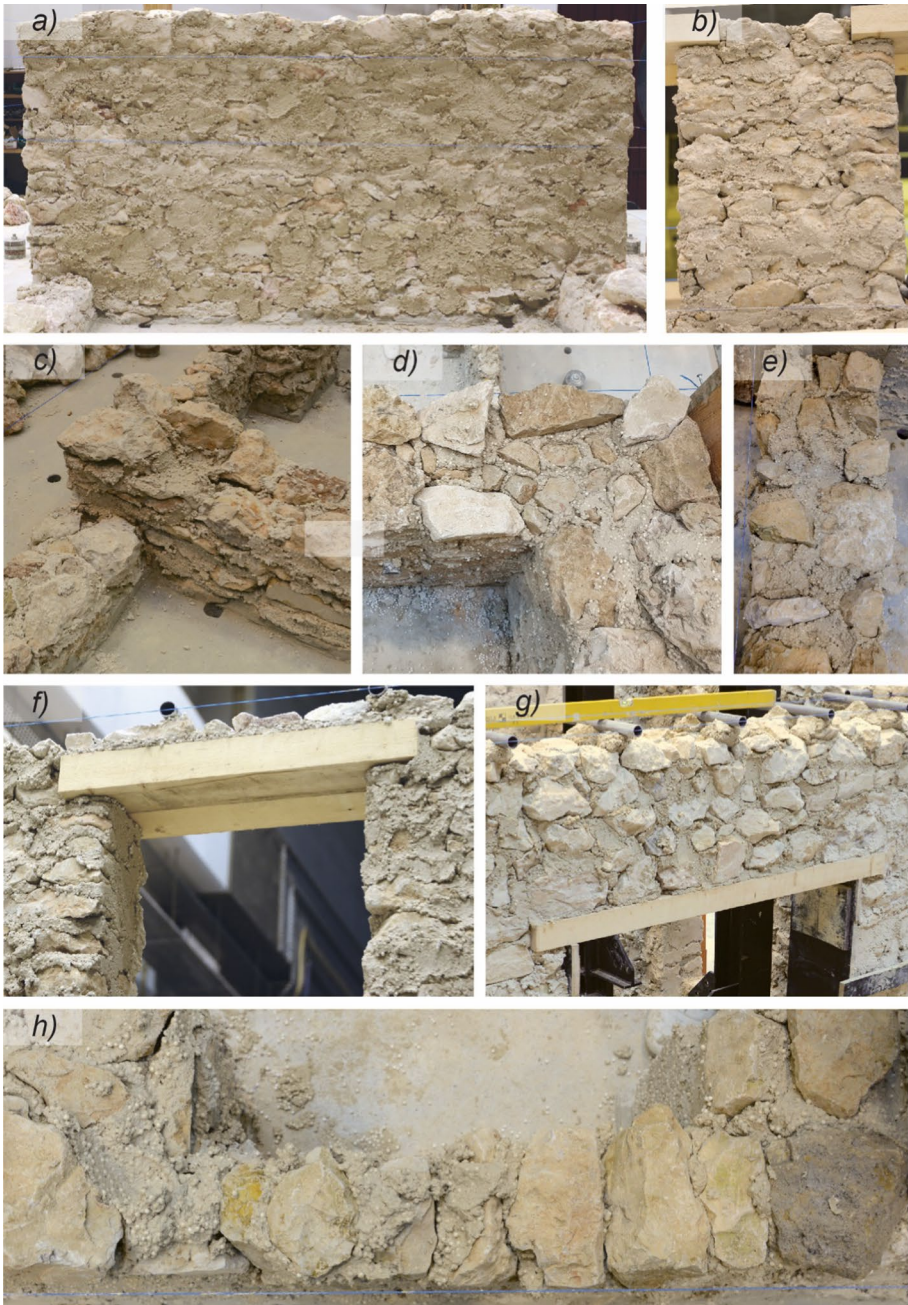
Fig. 5 Masonry typology: **a-b** Masonry texture; **c-d** Construction detail of a corner; **e** Horizontal section; **f** Detail of a lintel; **g-h** Construction detail of a spandrel

Walls were constructed as double-leaf stone masonry without interlocking between the leaves, except for through stones placed at opening edges and building corners, as shown in Fig. 5. Stone scraps mixed with mortar filled the voids between the leaves, which amounted to about 10% of the volume. The construction material reproduced the University of Pavia's shake table test as much as possible (Senaldi et al. 2019a; Guerrini et al. 2019), to facilitate numerical model calibrations. Table 1 summarises the material properties of the mortar and masonry, with those of the University of Pavia's specimen (Guerrini et al. 2017; Senaldi et al. 2018). Three-point bending, and compression tests were performed on mortar specimens after curing for 28 days. To derive masonry compressive and tensile strength, three vertical and three diagonal compression tests were performed on masonry wallettes, 17 months after their construction and nine months after the shake table test. The shake table test was carried out 8 months after completion of the half-scale aggregate. The delay in material and shake-table testing was due to the pandemic.

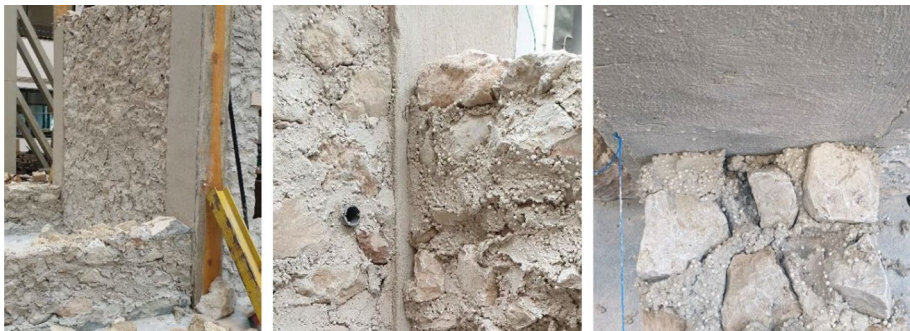
Fig. 6 Interface between the units in the stone masonry aggregate specimen

The two structural units constituting the aggregate were connected by mortar alone without interlocking stones. Unit 2 was constructed first as the older unit of the aggregate. The contact surface of Unit 2 was smoothed with a layer of mortar before constructing the adjacent facades of Unit 1, which ensured no interlock between the units. This detail was chosen to facilitate separation during the test and to create a clearly defined boundary condition between the two units. Figure 6 shows the interface between the units.

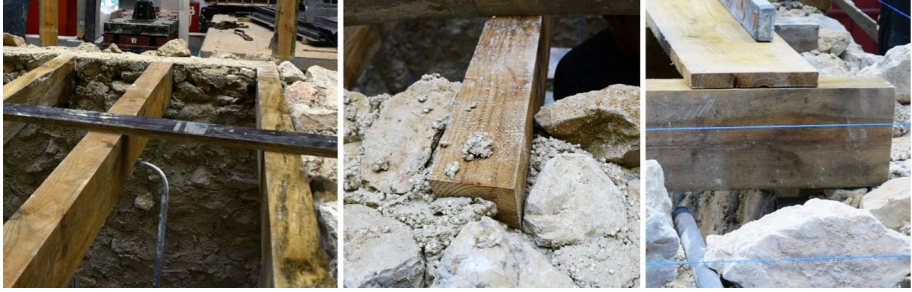
Fig. 7 Beam supports at the 1st floor of Unit 2 of the masonry aggregate specimen

Floors were composed of wooden beams with a cross-section of 8×16 cm that were simply supported on the masonry walls (Fig. 7). The beam support length was 20 cm for the 1st storey of Unit 2, and 15 cm for both Unit 1 and the 2nd storey of Unit 2. Unit 1 beams

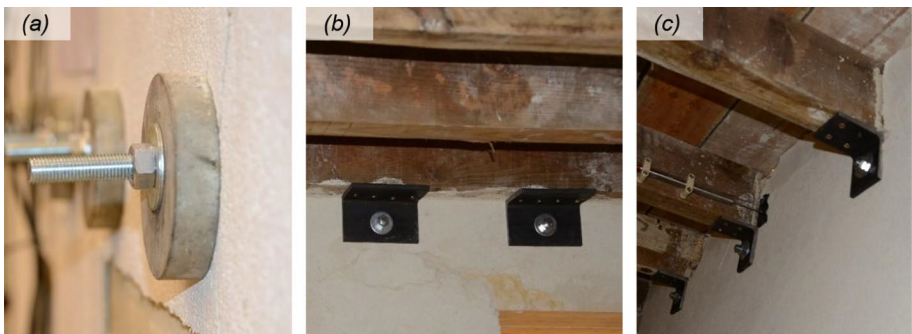
Fig. 8 Details of the strengthening interventions against out-of-plane wall overturning: **a** Bearing plate connection on the exterior of the wall; **b** Steel angles along the edge beam parallel to the wall; **c** Steel angles at the beam supports

PVC tubes were placed in the walls of both units, under each beam support and along beams running parallel next to walls, to allow locally strengthening of the structure. Strengthening included steel angles fastened to the beams and steel bearing plates on the wall outer surfaces, connected though the walls by threaded rods inserted within the PVC tubes. The rods were manually post-tensioned. The details of the intervention are shown in Fig. 8. These improved connections between beams and walls can contrast out-of-plane mechanisms and ensure a box-type behaviour of the building. Strengthening measures were installed after Run 2.1, during which the onset of out-of-plane wall overturning was observed on Unit 2, as shown later in Table 4.

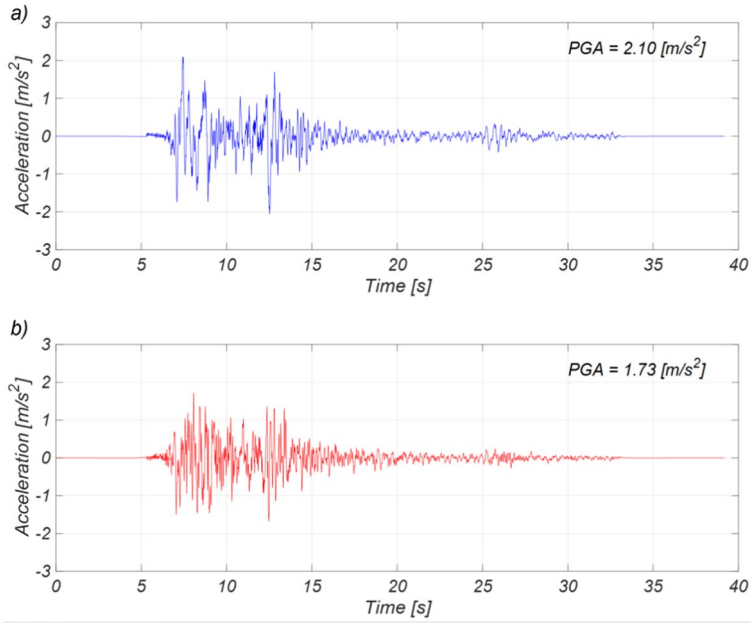
Fig. 9 Processed acceleration time histories of the Montenegro 1979 earthquake recorded at the Ulcinj-Hotel Albatros station, with the scaled time step: **a** East–west component and **b** North–south component

The aggregate specimen was tested under one- and two-component excitations, using the horizontal records of the 1979 Montenegro earthquake from the Ulcinj-Hotel Albatros station (Luzi et al. 2016). These ground motions are plotted in Fig. 9 as time series and in Fig. 10 as elastic response spectra, with time and periods scaled according to the similitude law (Senaldi et al. 2019a; Guerrini et al. 2019). The east–west component was applied in the longitudinal direction (positive y-direction), and the north–south component in the transverse direction (negative x-direction).

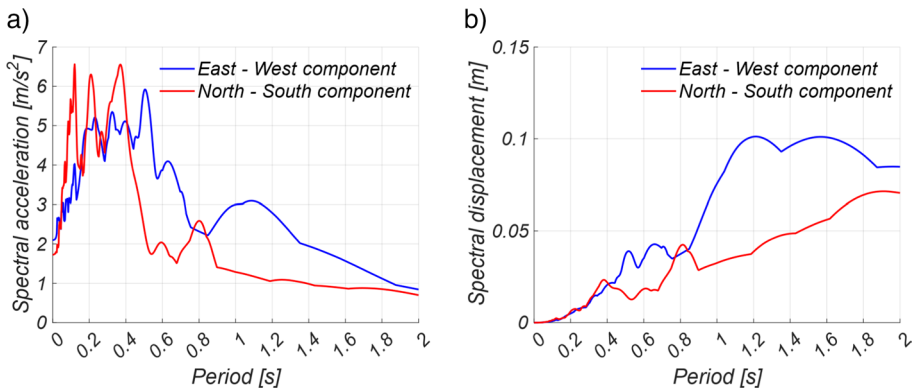
Fig. 10 Elastic response spectra of the Montenegro 1979 earthquake recorded at the Ulcinj-Hotel Albatros station for 5% damping ratio, with the scaled period: **a** Acceleration and **b** Displacement

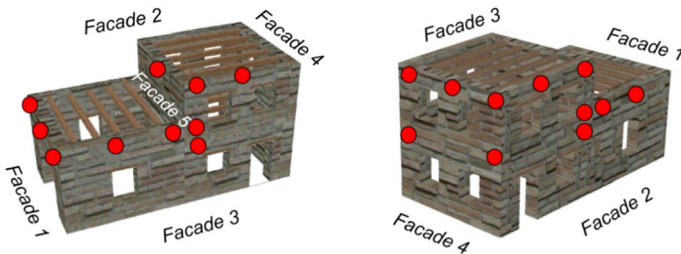
Fig. 12 Layout of accelerometers

Forty accelerometers recorded the accelerations of the foundation and the in- and out-of-plane accelerations of the masonry walls. The relative displacement of points were monitored with linear variable displacement transducers (LVDTs) and potentiometers; LVDTs were also used to record the relative displacement between wooden beams and masonry walls. Optotrak LED, Krypton, and Hamamatsu optical measurement systems were used to monitor absolute displacements of chosen points; the absolute displacement measures were used to compute the interface opening between the units. The layout of accelerometers is shown in Fig. 12. The layout of displacement measurements is shown in Fig. 13.

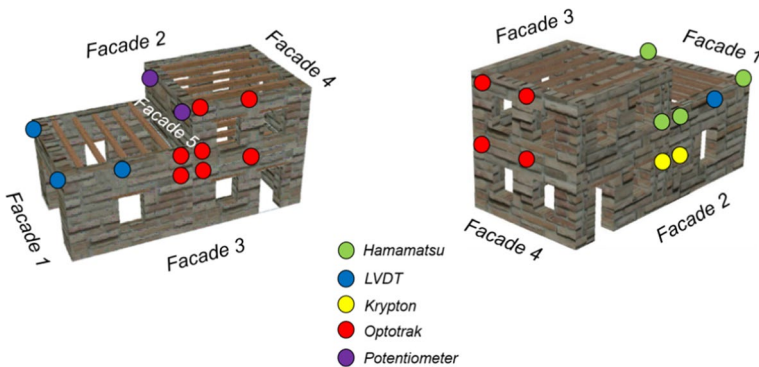
Fig. 13 Layout of LVDTs, potentiometers and optical devices (excluding LVDTs measuring beam-to-wall relative displacement)

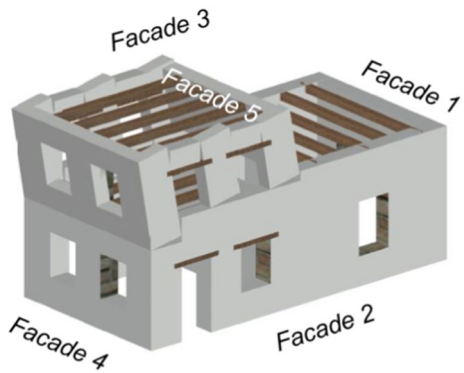
Fig. 16 Illustrative deformed shape of Unit 2 for test run 2.1

Out-of-plane cracks were visible at the 1st floor level of facade 4 with residual width up to 0.6 mm, with extensive cracking of the top spandrels of the same facade. Two out-of-plane horizontal cracks were detected on the partition wall (facade 5), at its bottom and at the level of Unit 1 roof. The cracks at the 1st floor level of Unit 2 on facade 4 and the roof level of Unit 1 on facade 5 confirm the interaction with the adjacent unit in the formation of the damage mechanism. Out-of-plane and in-plane cracks were continuous around corners; in fact, thanks to the interlock between orthogonal walls, the end piers of longitudinal facades acted as webs in the out-of-plane overturning mechanism of the transverse walls (Fig. 16).

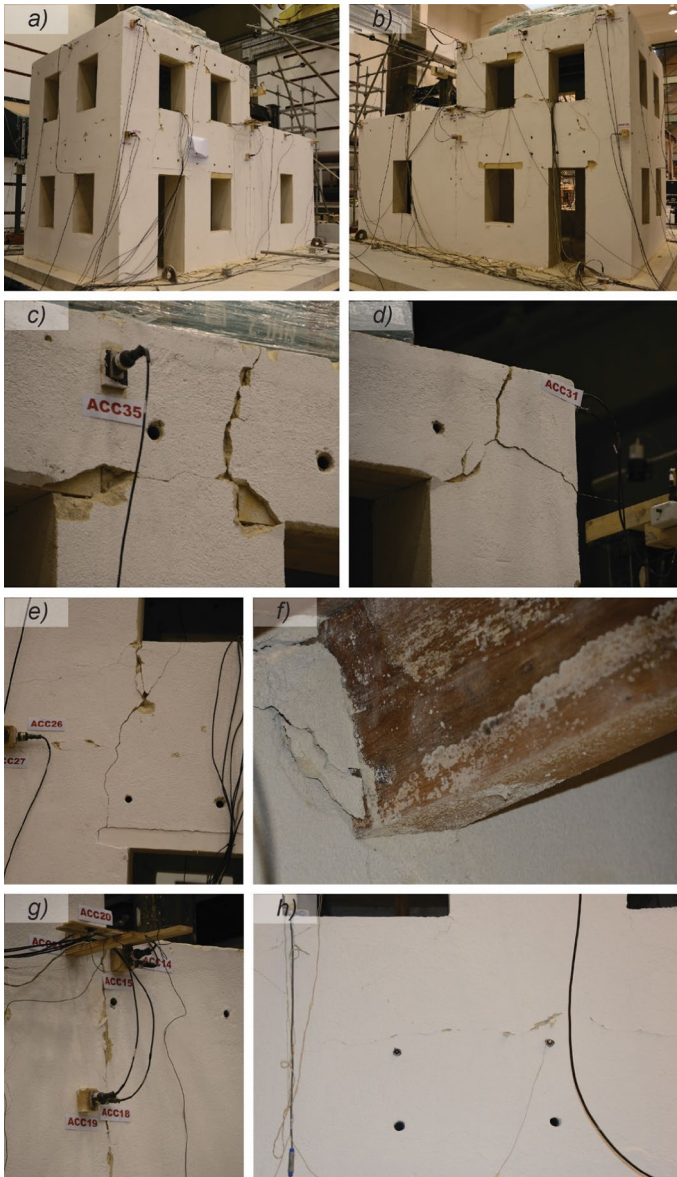
Fig. 17 Damage observed at the end of test run 2.1: **a-b** External view of the aggregate; **c** Flexural cracking of a 2nd floor spandrel and at the top of a 2nd storey pier of Unit 2; **d** Cracking and near-detachment of the top of a 2nd storey corner of Unit 2; **e** Flexural cracking of a 1st floor spandrel of Unit 2; **f** Slip of a 2nd floor joist of Unit 2; **g** Damage at the interface between the units; **h** Horizontal crack at the 1st floor level of facade 4 of Unit 2

Significant interaction, separation and pounding occurred at the interface between the structural units. The maximum recorded openings of the joint were 20.7 mm and 0.6 mm in the longitudinal and transverse directions, respectively. Unit 1 was nearly undamaged, apart from a few hairline cracks that spread horizontally from the interface between units. The damage on facades, interface, and beam supports after run 2.1 are shown in Fig. 17.

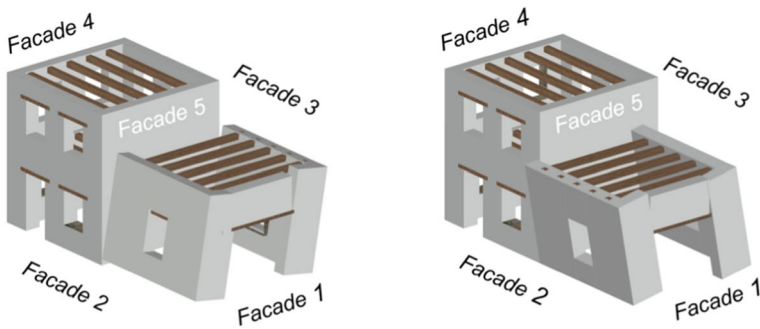
Fig. 20 Illustrative deformed shape of Unit 1 for run 2.2S

Finally, the specimen was subjected to run 2.2 in the transverse direction, which approached nominal run 3.2 for short period structures, as shown in Fig. 11. The crack maps for this run are shown in Fig. 19. No new cracks or amplification of previous damage was detected in Unit 2. However, in-plane flexural cracking of the spandrels and piers of facade 1 was observed, as Unit 1 developed the damage mechanism illustrated on Fig. 20.

The residual crack width was up to 3.0 mm and 1.0 mm for spandrels and piers of facade 1, respectively.

Thin out-of-plane horizontal cracks were observed at the pier bases of facades 2 and 3 in Unit 1. The cracks were continuous around the corners of the building, meaning that the end piers of the transverse facades acted as flanges in the out-of-plane overturning mechanism of the longitudinal walls, thanks to the interlock between orthogonal walls. The maximum residual width of these cracks was 1.0 mm and 0.4 mm for facades 2 and 3, respectively. Indications of beam sliding at the supports were observed and confirmed via LVDT measurements, which showed residual displacements of 1.0 mm and 3.3 mm on facade 2 and facade 3, respectively.

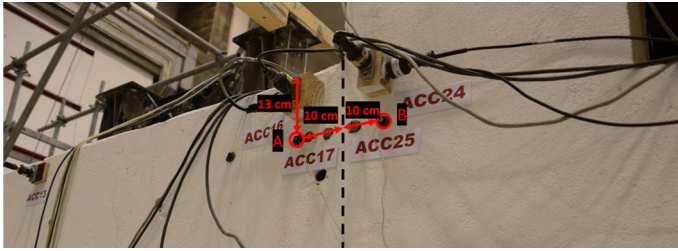
Fig. 21 Position of Optotrak markers on facade 3 used to calculate relative displacements at the interface between the units

Optotrak device is under a millimetre, and the recording frequency was set to 200 Hz, which was considered sufficient to capture the effects of dynamic motion. Two markers were placed close to the top of the interface on facade 3, 10 cm away from the dry-joint on each side, as illustrated on Fig. 21.

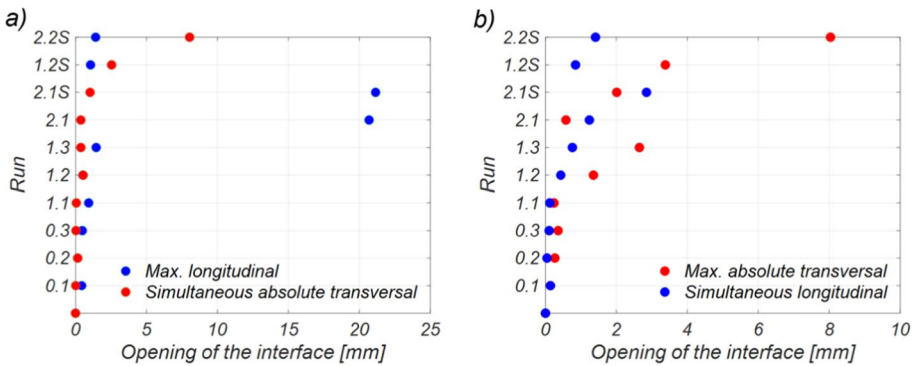
Fig. 22 Openings of the interface joint: **a** Peak values in longitudinal (blue) with simultaneous absolute values in transverse (red) directions; **b** Peak absolute values in transverse (red) with simultaneous values in longitudinal (blue) directions

The maximum values of relative and residual displacements at the interface for each run are shown in Table 5. During the bidirectional run 1.3, the maximum longitudinal opening increased up to 1.45 mm, while the maximum positive and negative transverse opening reached 2.33 mm and 2.65 mm, respectively. This indicates the out-of-plane vibration of facades 2 and 3 of Unit 1, which was later confirmed by crack maps and illustrated in Fig. 20. During the same run, the negative longitudinal displacement of -0.58 mm at the interface showed that the units were already experiencing pounding.

The largest transverse displacement at the interface was observed during run 2.2S with the maximum absolute value of 8.04 mm. After the same run, the residual transverse displacement was -0.94 mm, which was the largest residual value observed on the interface in either direction.

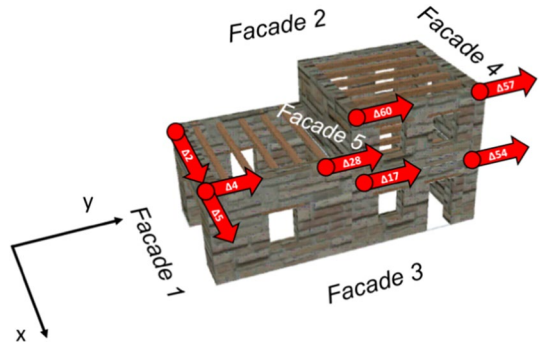
Fig. 23 Markers used to calculate the in-plane facade elongations

at the two corners of facades 1 and 2. Figure 23 shows the displacements used to calculate the facade elongations according to Eqs. (3) through (6):

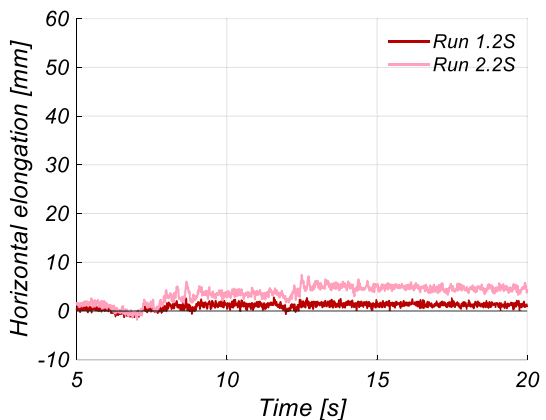
Fig. 25 Time history of the transverse elongation of facade 1 of Unit 1

For the last two transverse runs (run 1.2S and run 2.2S), the time-histories of the elongation of facade 1 are shown in Fig. 25. Residual values were approximately 1.4 mm and 4.7 mm for run 1.2S and run 2.2S, respectively. This confirms the observed behaviour of Unit 1, with the formation of the first cracks and the development of the transverse flexural-rocking mechanism during run 2.2S.

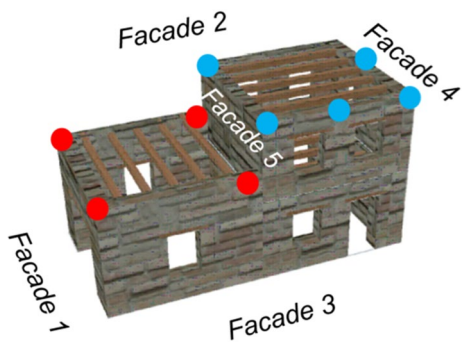
Fig. 26 Markers used to calculate global drift ratios: red for Unit 1, blue for Unit 2

The global drift ratio ($\tilde{\theta}_{j,AVG}$) represents the average displacement at the top of a unit divided by the total height of a unit, as given by Eq. 8:

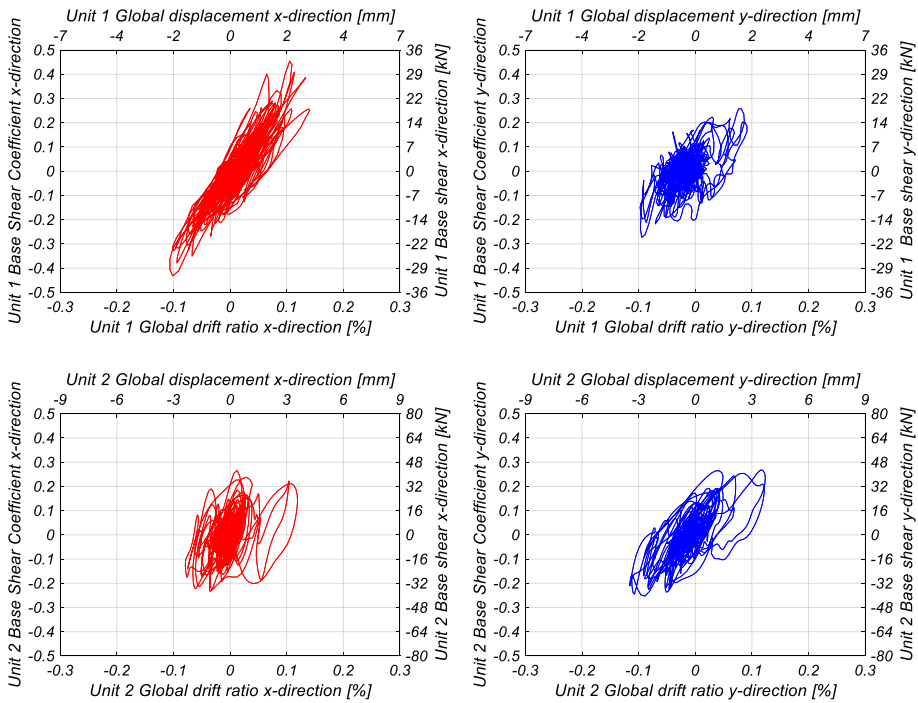
Fig. 27 Hysteretic responses in both directions for run 1.3

The hysteretic response for run 1.3, the strongest bidirectional run, is shown in Fig. 27. The hysteretic response of both units in both directions shows energy dissipation. At the same time, the only damage detected at the units after this run was cracking and separation at the interface.

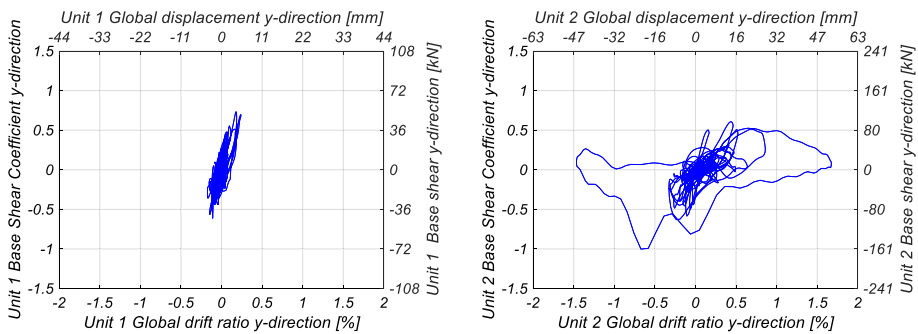
Fig. 28 Hysteretic responses in the y-direction for run 2.1

Figure 28 shows the hysteretic response for run 2.1 in the longitudinal y -direction. The formation of a soft-storey mechanism in the upper storey of Unit 2 resulted in anelastic hysteretic response, reaching global drift-ratio values greater than 1.5%. Figure 29 illustrates the behaviour for run 2.1S, where accumulated damage increased the global drift ratio of Unit 2 to values above 3%, even if retrofitted.

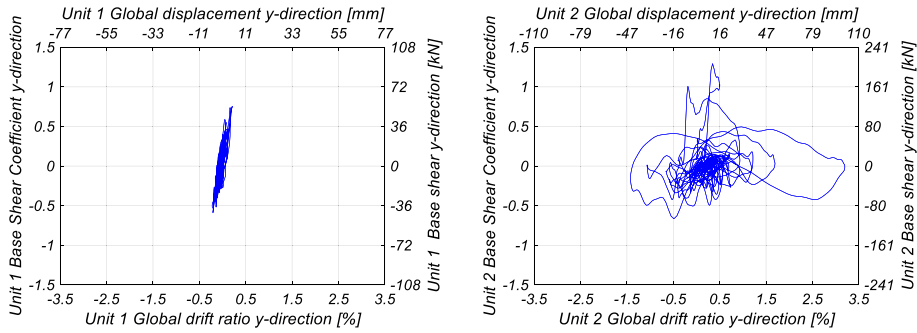
Fig. 29 Hysteretic responses in the y-direction for run 2.1S

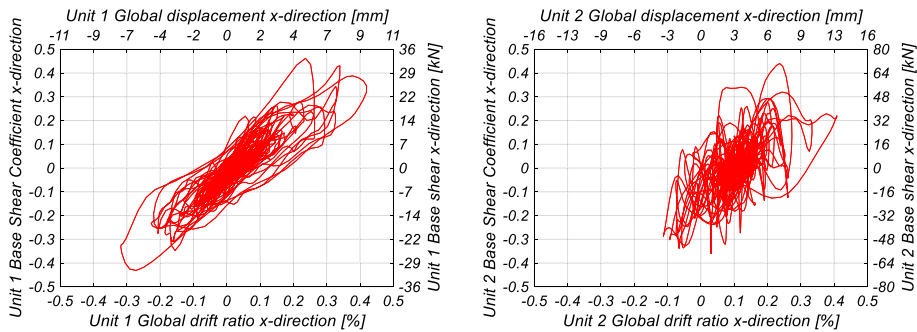
Fig. 30 Hysteretic responses in the x-direction for run 2.2S
